November 3, 2009

Re: Closure Plan for 1280 Vent La Sal/Snowball Permit Number M/037/026

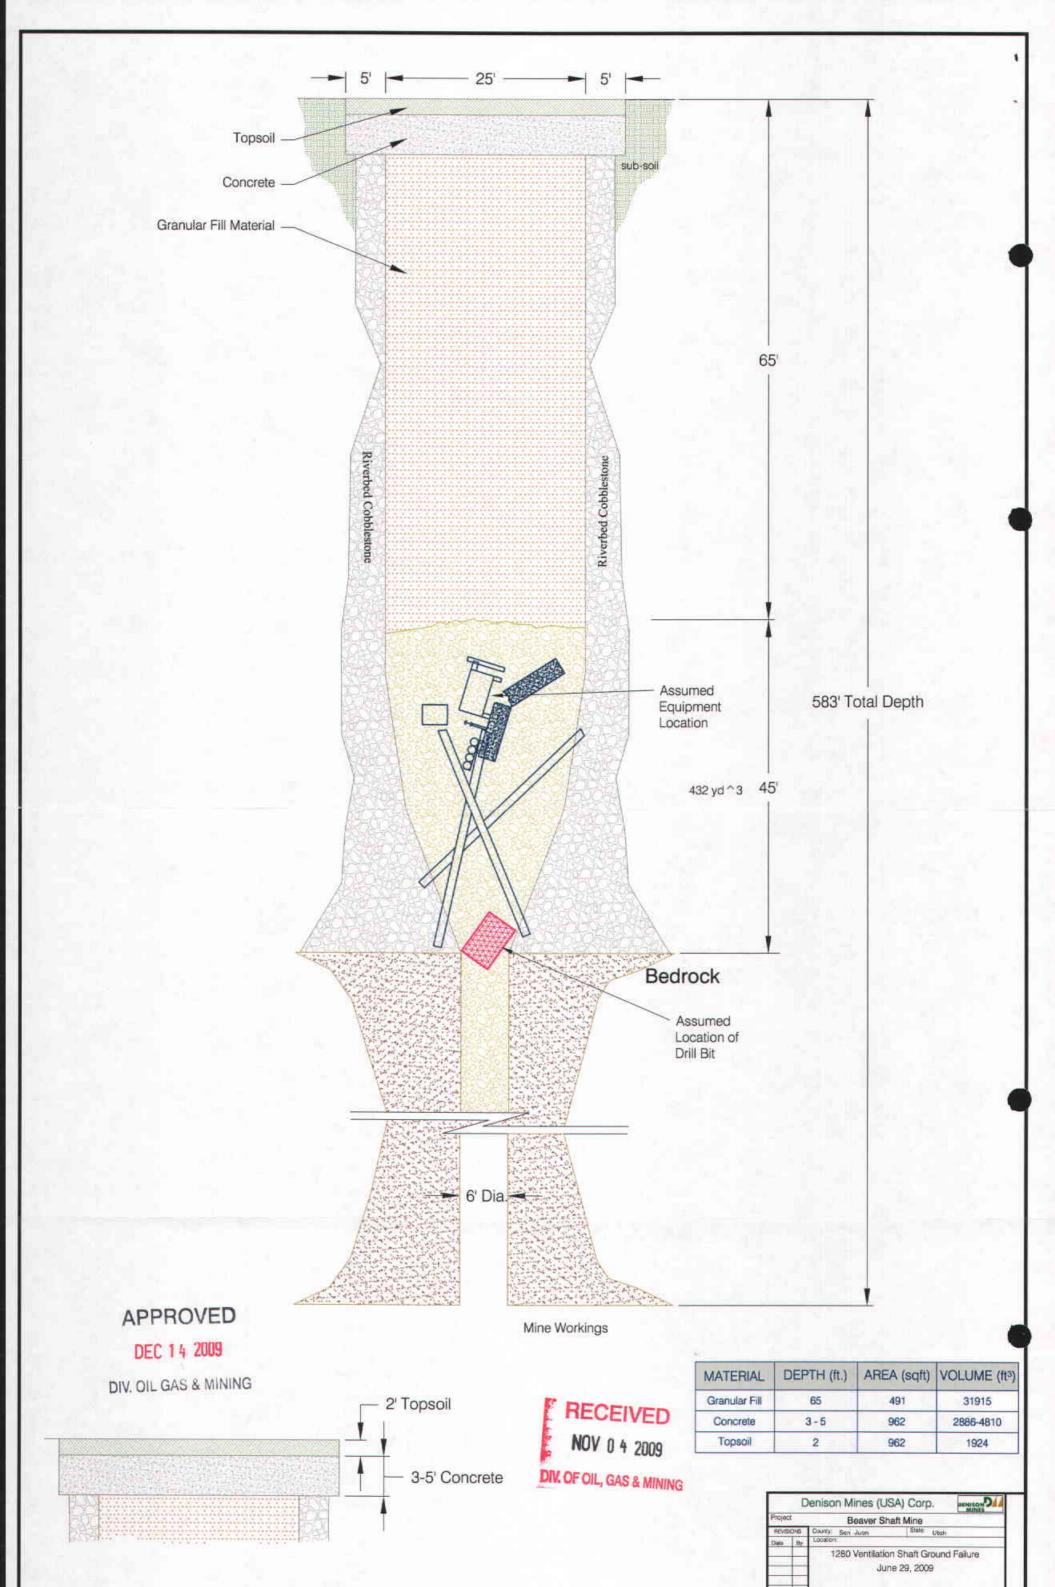
The opening on the ground surface is approximately 28 feet by 18 feet, and the surface soil type is sand and gravel mix. The cement pad to which the drill was anchored was 15 feet by 15 feet and 26 inches thick. The drill is totally covered with material and the material is approximately 65 feet below the surface. The area has been barricaded and secured.

Denison will close the drill hole by backfilling the hole with granular fill material, providing a 3 to 5 foot thick concrete pad extending approximately 5 feet outside of the existing hole diameter (total diameter of 30 feet over the approximate 25 foot hole) and then covering the area with 2 feet of topsoil. Denison will seed the area with the UDOGM approved seed mix. Gravel fill material will come from either the County owned gravel pit, located less than 5 miles away from the site. A schematic of the closure process is attached.
